CH-46 Blade Stall During the Conduct of Dynamic Component Upgrade and Fuselage Strain Survey Tests

**Lieutenant Colonel Mike L'Heureux USMC
Naval Rotary Wing Aircraft Test Squadron**

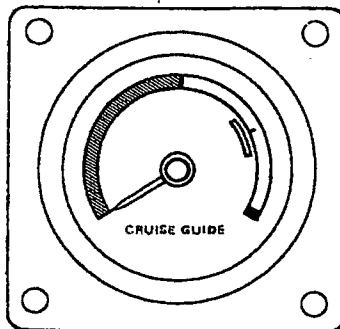
Figure 1

The CGI gauge is not always monitored due to its location and poor ergonomic qualities. The team found that it is a very accurate indicator of events that are causing fairly serious strain damage. Some problems with the gauge include;

Needle Sensitivity- The indicating needle sometimes varies significantly throughout its range, this is very similar to the needle indication when the strain gauge is disconnected and tends to de-sensitize the operator.

Prohibited Area- The red (prohibited area) of the gauge is hard to distinguish as being red. It is a small red line where the needle pegs. The data indicated loads in excess of those that the operator was able to read off the CGI. During numerous flights, the gauge was monitored and there was a noted time delay that held the needle into the red (pegged/prohibited) area for approximately 4 seconds. Even when the proper recovery procedures are applied, the gauge will remain pegged for up to 4 seconds. Due to this delay, the operator is unsure of the immediate effectiveness of the recovery procedures. In addition, the operator may miss this instrument while flying a particularly demanding flight phase that requires full outside attention.

Stall Indication Warning- One of the primary considerations the team considered was the incorporation of an aural alarm. This would cue the operator when a blade stall incident was imminent, and provide the cues necessary to implement the correct recovery procedures.

Damage Indication- The ability to record the excursions for each flight would assist in determining an appropriate service life adjustment if required. Currently, the incorporation of the military standard 1553 data bus and Communication, Navigation, Control System in the helicopter provide a cost effective means for realizing this system. This would become a relatively simple but effective health usage monitoring system.

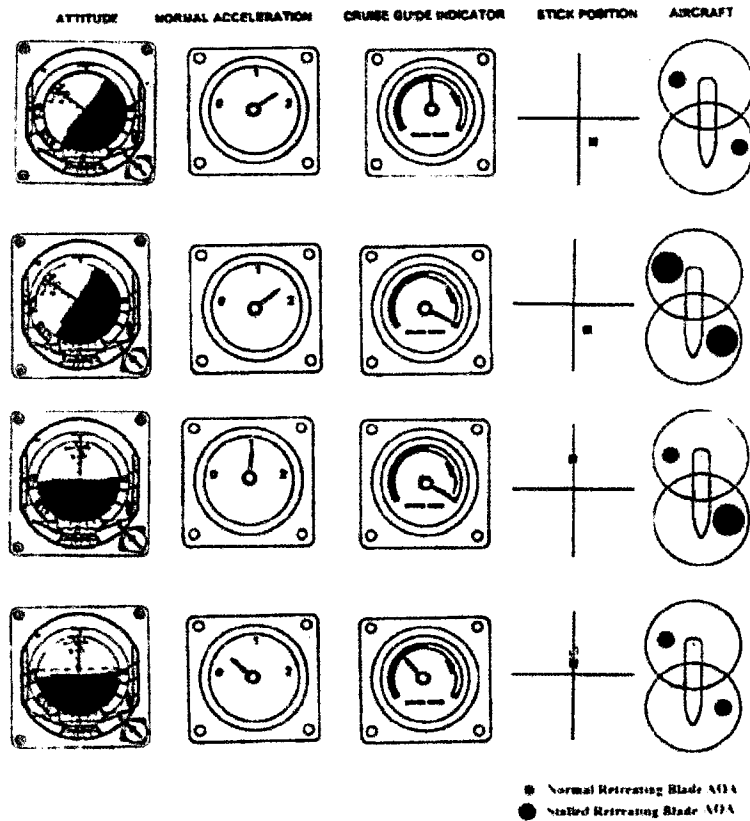
Aircraft Blade Stall Event Sequence
Figure 6

When the aircraft returned to wings level flight, and the aft rotor system was no longer in the disturbed air flow of the forward rotor system, the stall condition abruptly ended, the longitudinal control effectiveness abruptly returned. This caused a violent nose down pitch, the aircraft went from a positive 1.8 "g" flight, to positive .3 "g". The ensuing damage occurred during the recovery which also included a pitch oscillation episode. This is a documented deficiency that has been known to occur during rapid longitudinal cyclic inputs and is due to a differential air speed hold (DASH) actuator phase shift phenomena. A graphical representation of this sequence of events is presented in figure 6.

The above graphical representation of events was deduced from the data collected with real time telemetry, in addition to air crew interviews of the event. By examining the data, which, in addition to vehicle state parameters/rates included control positions/structural loads, the cause of aircraft damage became readily apparent.
