DODIG-2013-103

## Boeing Overstated Contract Requirements for the CH-47F Helicopter

SUBJECT: Boeing Overstated Contract Requirements for the CH-47F Helicopter  
(Report No. DODIG-2013-103)

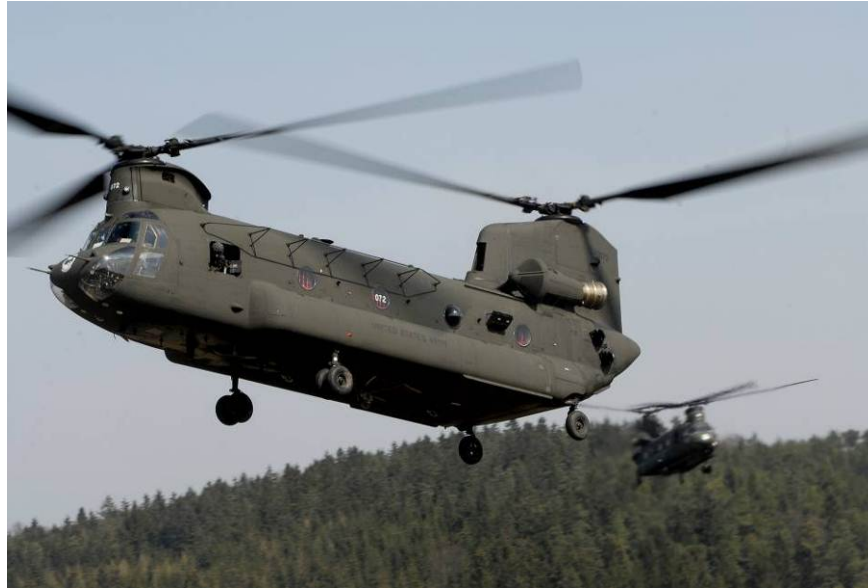
**Figure 1. CH-47 Chinook Helicopter**

The CH-47 mission is to transport ground forces, supplies, ammunition, and other battle-critical cargo in support of worldwide combat and contingency operations. The CH-47F supports the Army's requirement to be strategically responsive across the full spectrum of operations. The CH-47F provides continued support, coverage and sustainment of maneuver, fire support, air defense, and survivability mission areas. Figure 1 shows the Chinook, manufactured by Boeing in Philadelphia, Pennsylvania.

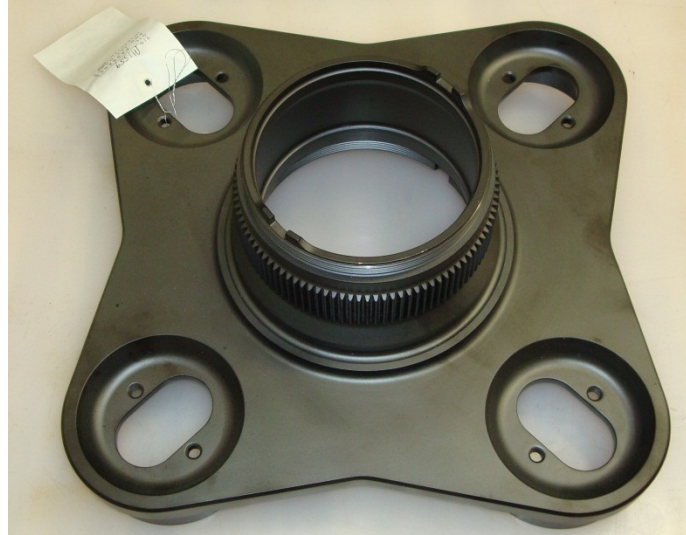
**Figure 2. Carrier, Part Number 145D0104-3**

**(FOUO)** For example, part number 145D0104-3, a carrier, (Number 11 on Table 1), shown in figure 2, had a quantity of two for each of the 116 remanufactured helicopters, meaning that the contract required a total quantity of 232 carriers. Of the 232 carriers required, Boeing estimated it would need 59 new parts<sup>5</sup> to replace parts on the remanufactured helicopters it could not salvage, resulting in a replacement rate of 25.4 percent.

Figure 2 shows a carrier, part number 145D0104-3.

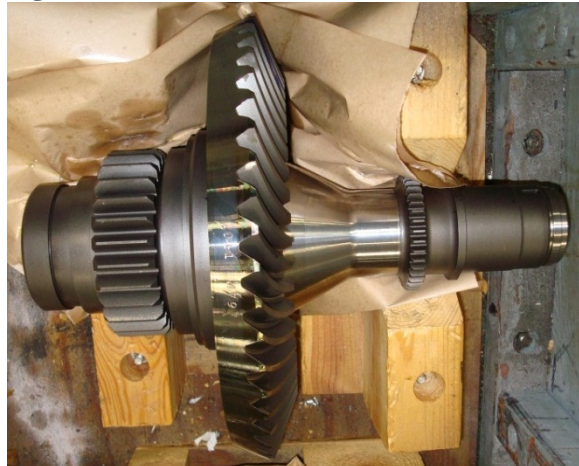
**Figure 5. Gear – Part Number 145D1305-3**

(FOUO) For example, the historical replacement rate for part number 145D1305-3, a gear (Part Number 9 in Table 2) was 5.0 percent. However, Boeing proposed a replacement rate of 32.8 percent in the multi-year I contract. Based on TAMMS-A data for the first 50 remanufactured helicopters, the actual replacement rate was 10.0 percent. For the multi-year II contract, Boeing proposed a replacement rate of 17.4 percent. Figure 5 shows a picture of the gear, part number 145D1305-3.

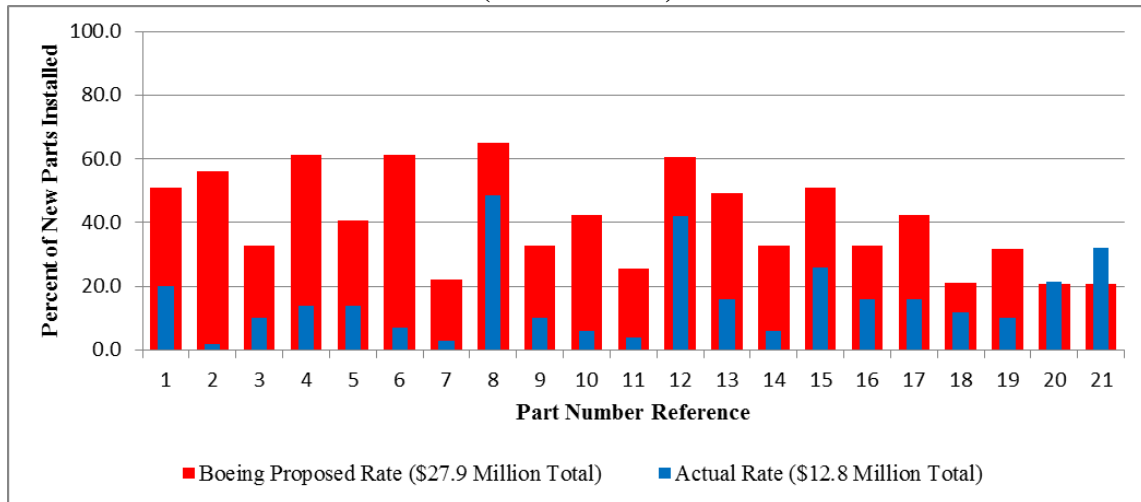
**(FOUO) Figure 6. Safety Stock Contract Requirements Were Overstated (Multi-Year I)**

requirements for the 21 parts by \$15.1 million. Figure 6 shows that Boeing significantly overstated replacement rates for safety stock in the multi-year I BOM compared to actual replacement rates. See Appendix C, Table C-1, for details of the overstatement.

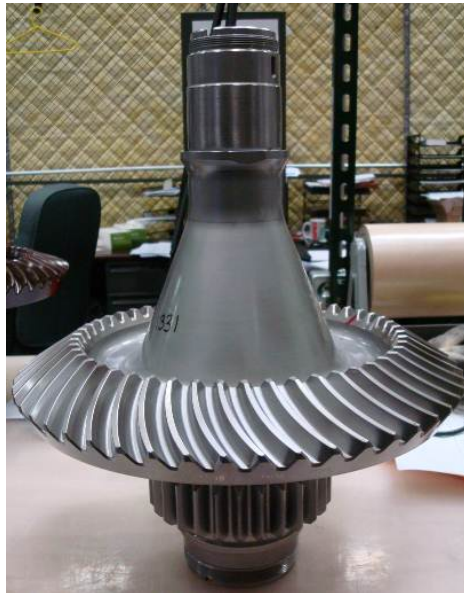
**Figure 7. Gear – Part Number 145D2305-3**

(FOUO) For a gear, part number 145D2305-3 (Part Number 2 in Figure 4), valued at \$1.7 million, Boeing proposed a requirement for 65 new parts (56.0 percent replacement rate) to replace those parts that could not be reused on the remanufactured helicopters. TAMMS-A showed that for the first 50 remanufactured helicopters, Boeing installed only one new part, a 2.0 percent replacement rate. At this rate, Boeing would need only three new parts for the remanufactured helicopters. As a result, Boeing overstated contract requirements for the gear by \$1.6 million.

Figure 7 shows a picture of the gear, part number 145D2305-3.

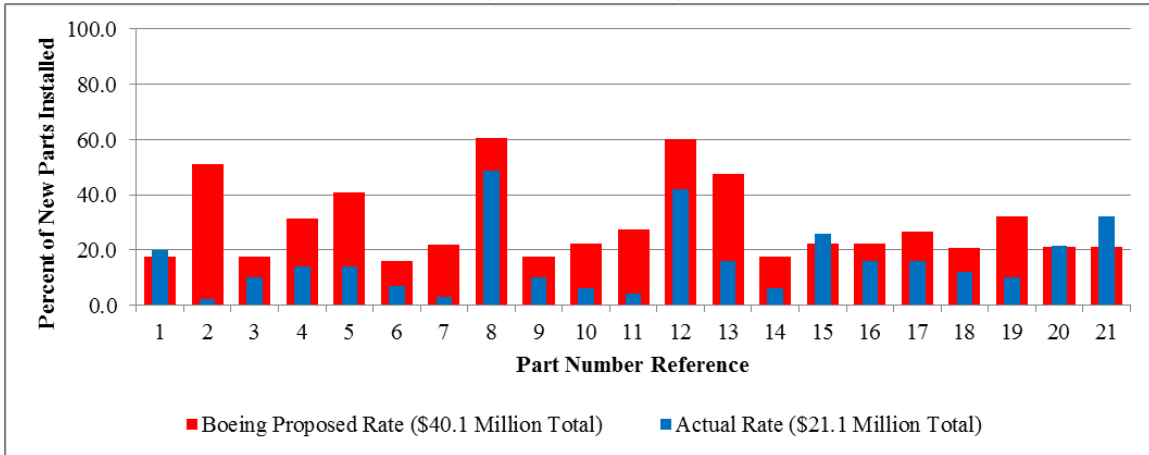
**(FOUO) Figure 8. Safety Stock Contract Requirements Were Overstated (Multi-Year II)**

Figure 8 shows that for the 21 parts reviewed, Boeing significantly overstated replacement rates for safety stock in the multi-year II BOM (January 2012) compared to actual replacement rates from the multi-year I contract. See Appendix C, Table C-2, for details.

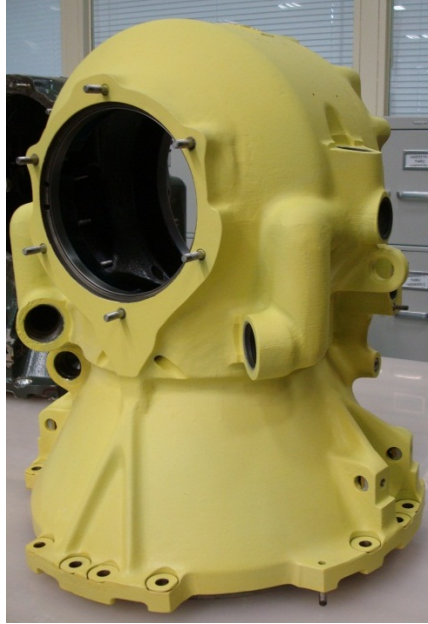
**Figure 11. Housing, Part Number 145D6303-4**

**(FOUO)** We determined that potential excessive costs for the overstated contract parts quantities ranged from \$7.4 million (rework/overhaul) to \$16.6 million (safety stock) for the multi-year I contract<sup>8</sup> (See Appendix D, Table D-1). For example, the multi-year I contract quantity requirement for a housing, part number 145D6303-4, was 232. Boeing proposed a total quantity of 374, which included the full contract requirement of 232 for rework parts and an additional quantity of 142 for safety stock. Therefore, Boeing’s proposed quantity exceeded the contract requirement by 142. As a result, potential excess costs for the housing range from \$1.2 million to \$2.6 million.

Figure 11 shows the housing, part number 145D6303-4.

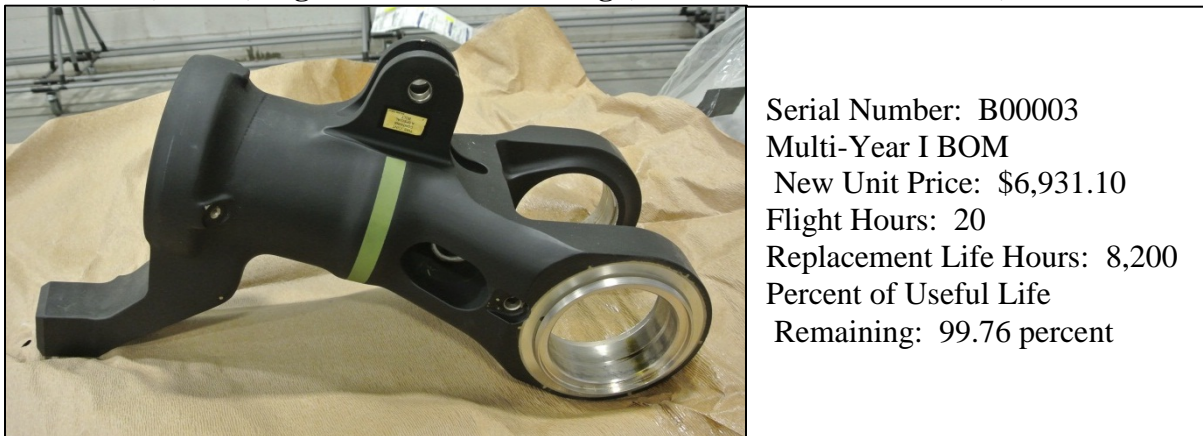
**(FOUO) Figure 16. Pitch Housing (Part Number 145R2075-16)**

(FOUO) As of July 11, 2012, TAMMS-A accounted for 211 pitch housings in Army inventory at New Breed. The 211 pitch housings ranged from having 20 to 5,485 flight hours, with an overhaul/replacement life of 8,200 hours. We calculated the median percent of useful life remaining for the pitch housings to be 88.48 percent. For example, serial number B00003 had only 20 flight hours recorded in TAMMS-A; therefore, the pitch housing had 99.76 percent of useful life remaining. Figure 16 shows a picture of the pitch housing, part number 145R2075-16.

During the audit, we brought these four parts to the attention of the Army. According to an Army official, the Army coordinated with the Corpus Christi Army Depot and planned to provide it the pitch housings. (See Figure 16.) The Army also stated that it worked to identify other users for the rotor hubs and that another DoD organization expressed an interest in reusing the parts. (See Figure 15.) Furthermore, the Army took action to address inactive CH-47F Government property at New Breed. Specifically, according to an Army logistics contractor, the Army made some parts available in the Plant Clearance Automated Reutilization Screening System, an excess Government inventory system that offered the parts to other potential users and subordinate commands. Army officials need to determine a use for the existing CH-47F Government-furnished property stored at New Breed.
